TRIP REPORT

TO: JFO File: Chuck Hayes / SOP-12017

Subject: 7-25-16 Site Visit in response to spill at Chuck Hayes Facility

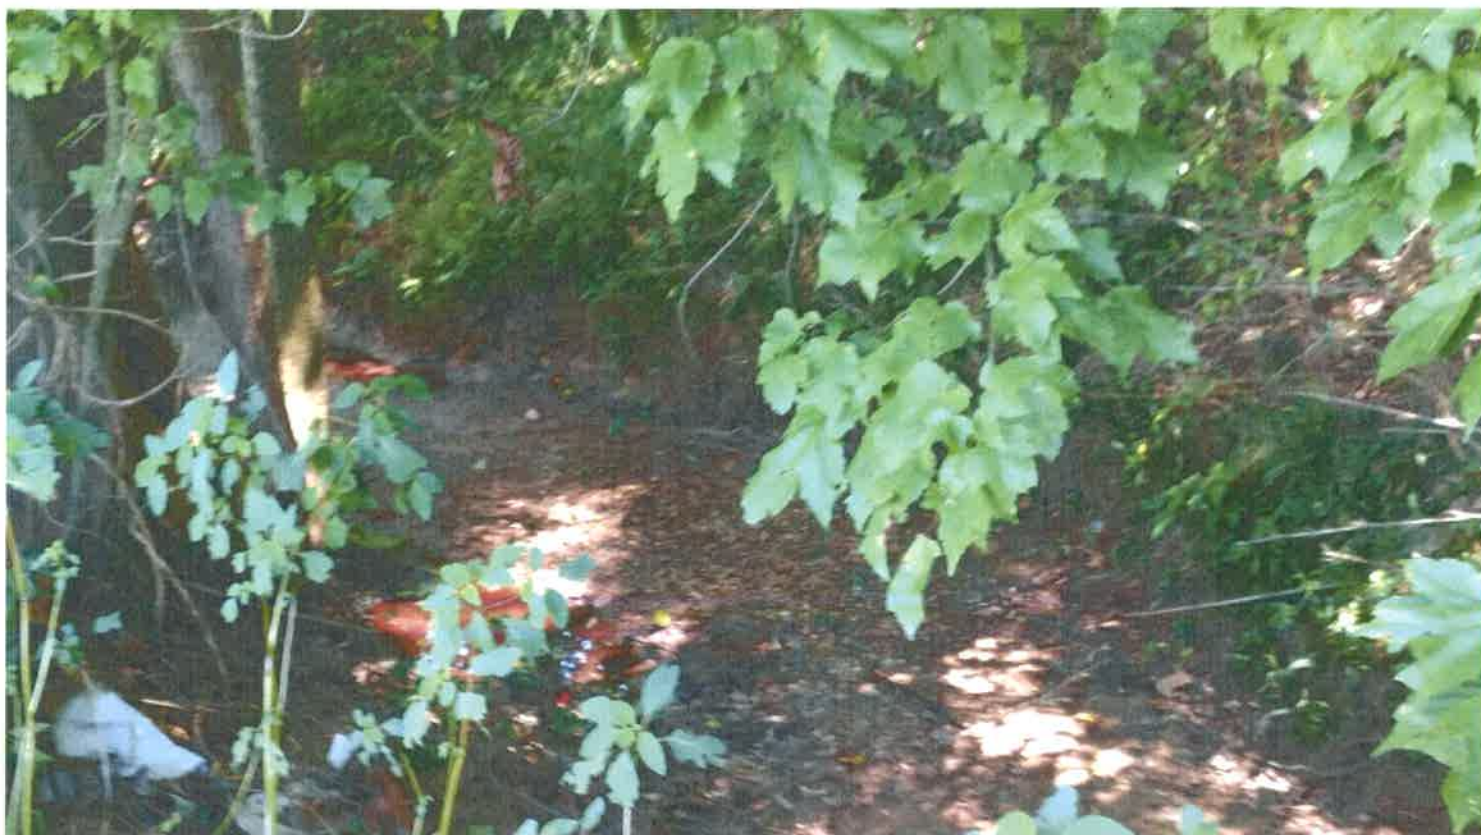
Picture 27

Picture provided by Mr. Chuck Hayes on July 27, 2016 after drainage ditch was pumped out a second time.

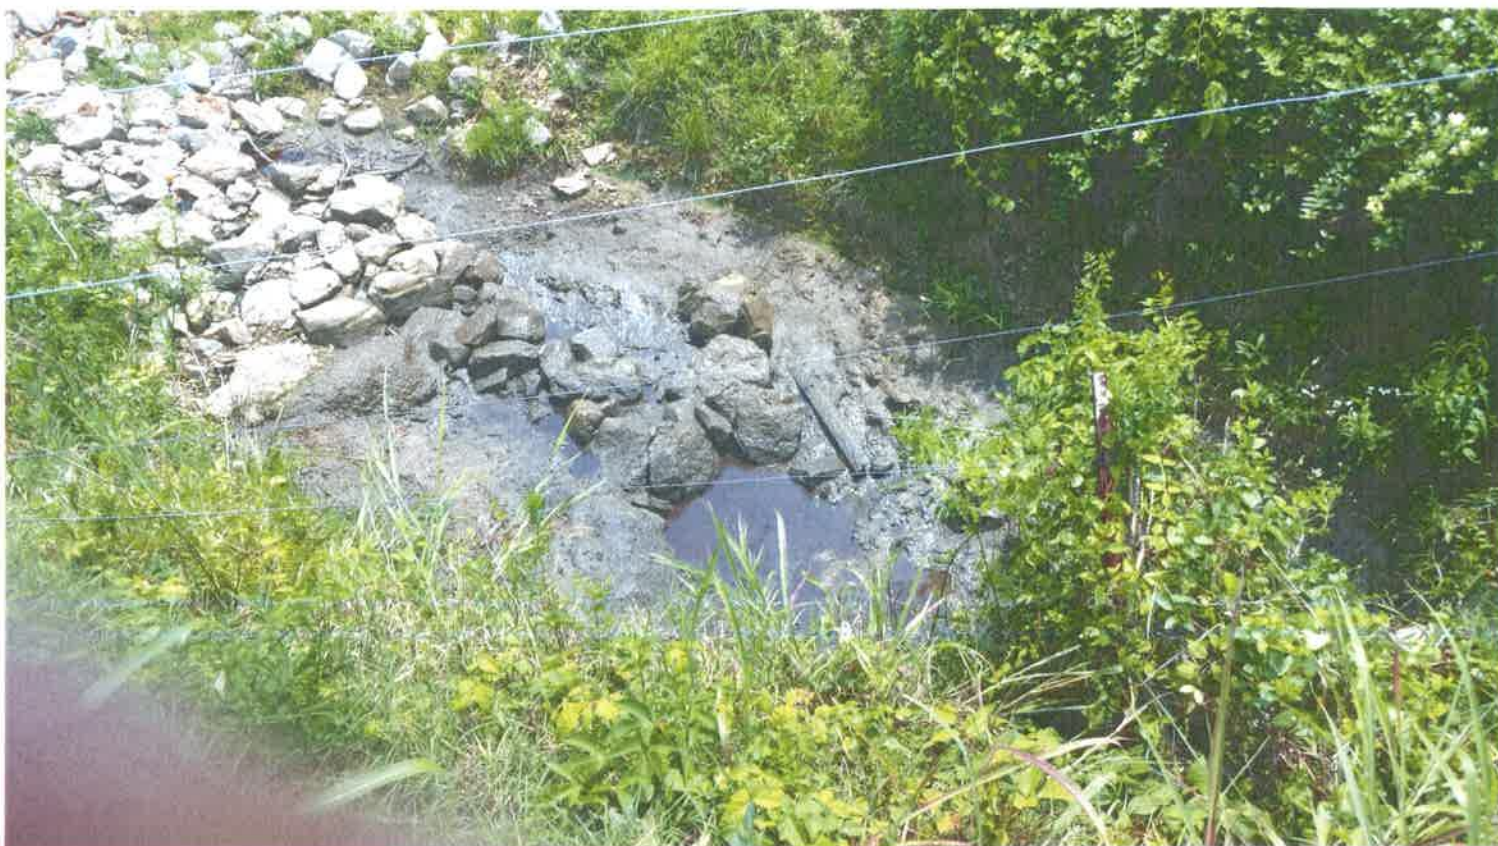
Picture 28

Picture provided by Mr. Chuck Hayes on July 27, 2016 after drainage ditch was pumped out a second time.
